Dryer Vent Safety

by Nick Gromicko and Kenton Shepard

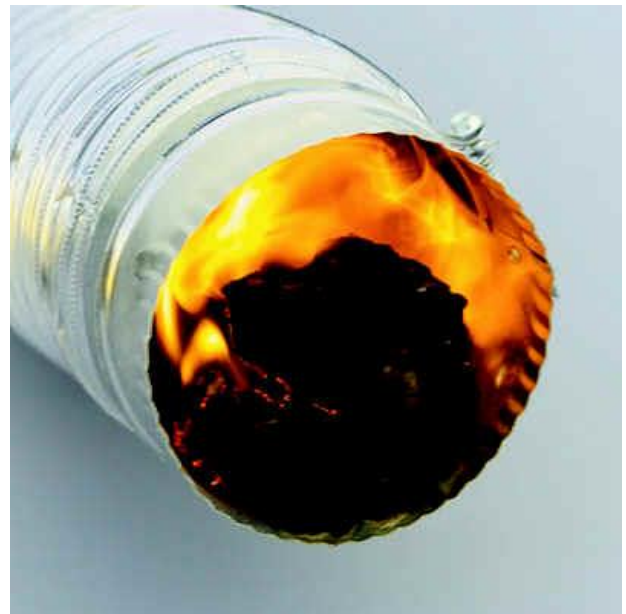
3. One of the reasons that restrictions are a potential fire hazard is that, along with water vapor evaporated out of wet clothes, the exhaust stream carries lint – highly flammable particles of clothing made of cotton and polyester. Lint can accumulate in an exhaust duct, reducing the dryer's ability to expel heated water vapor, which then accumulates as heat energy within the machine. As the dryer overheats, mechanical failures can trigger sparks, which can cause lint trapped in the dryer vent to burst into flames. This condition can cause the whole house to burst into flames. Fires

generally originate within the dryer but spread by escaping through the ventilation duct, incinerating trapped lint, and following its path into the building wall.

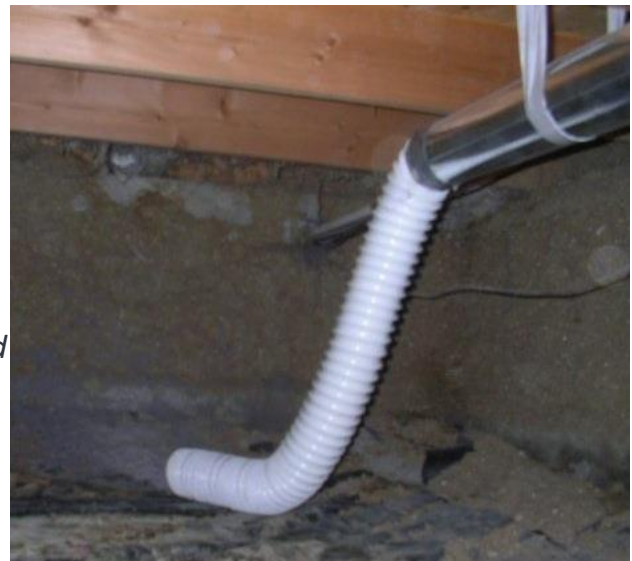
Inspectors will see many dryer vents terminate in crawlspaces or attics where they deposit moisture, which can encourage the growth of mold, wood decay, or other material problems.

Sometimes they will terminate just beneath attic ventilators. This is a defective installation. They must terminate at the exterior and away from a door or window. Also, screens may be present at the duct termination and can accumulate lint and should be noted as improper.
