## Radon Inspection Report

SAMPLE REPORT ONLY  
 123 Radon Way  
 Macedonia, OH 44056  
 SampleTesting@gmail.com  
 (330) 348-1234  
 Building Type: Residential Single Family

**Inspection Report Date:** 02/05/2019

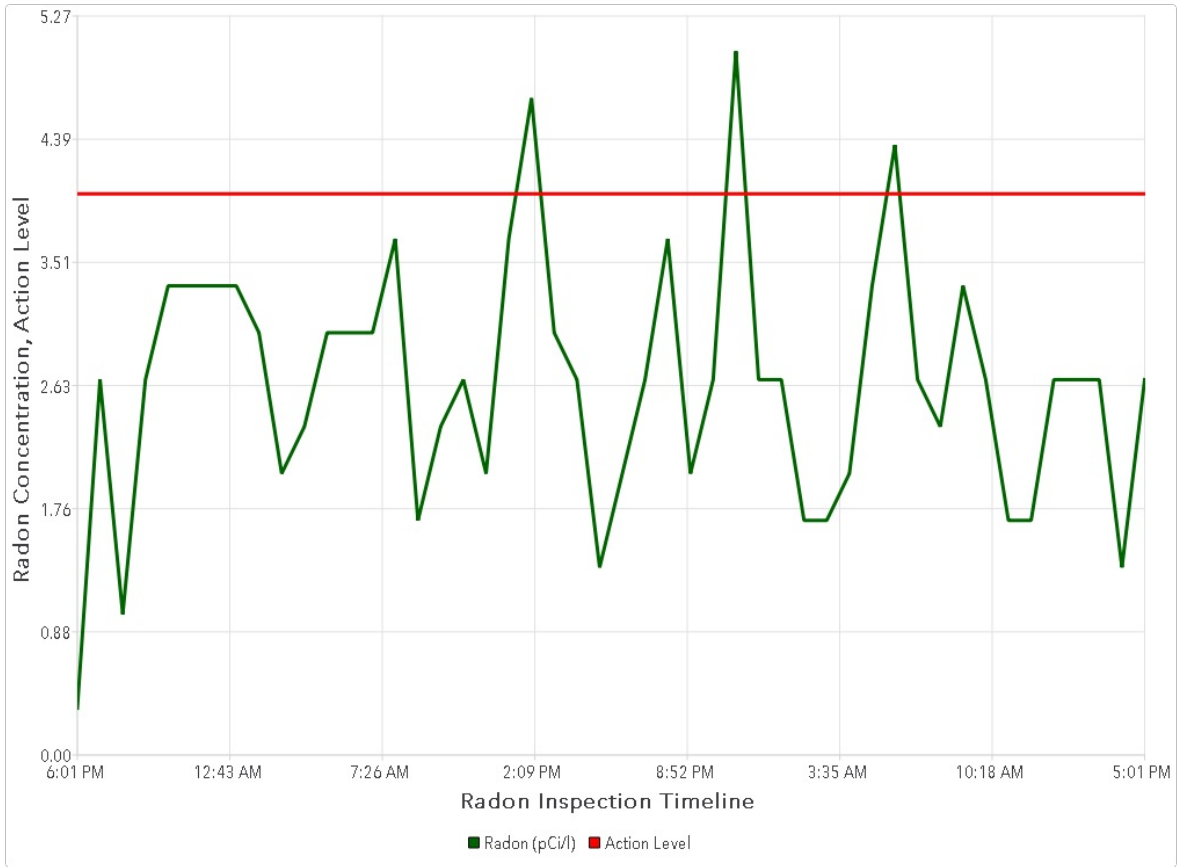
### Radon Inspection Chart

<u>CRM Location:</u>	<u>Start:</u>	<u>Stop:</u>	<u>Interval:</u>	<u>Duration:</u>	<b><u>Overall Avg:</u></b>	<b><u>EPA Average:</u></b>
First Floor Livingroom	12/22/2018 05:01 PM	12/24/2018 05:01 PM	1 hr	48 hr	<b>2.6 pCi/l</b>	<b>2.7 pCi/l</b>

<u>Measurement Units</u>	<u>Min</u>	<u>Max</u>	<u>Average</u>
Radon Concentration:	(pCi/l)	0.3	5.0	2.6

**Test Result: Pass**

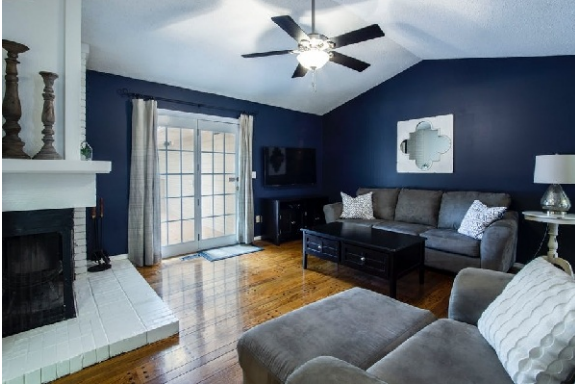
Testing took place in this room.
